## THE CORROSION PROBLEMS IN HOUSEHOLD WATER HEATERS OF SABRATHA CITY

Khalid H. Almadhoni<sup>1\*</sup> and Mohammad A. Ammar<sup>2</sup>

<sup>1</sup>Department of Mechanical Engineering, Faculty of Engineering, Sabratha University, Libya

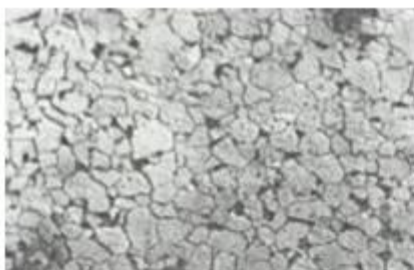
values became more positive, as a result, a large amount of scaling was formed. “PH” had an obvious effect on the “SI” value as shown in the sample “C”. Finally, these results revealed that, Sabratha city is suffering from scaling problems due to the high percentage of salts in the potable waters, which leads to decreasing the service life of the household water heater. The obtained results of metal microstructure investigation indicated the presence of ferrite-pearlite mixture with uniform grain size as shown in figure (6). The pearlite was distributed evenly with no signs of banding. The microstructure was typical of well-annealed low carbon steel. However, some porosity was occasionally observed. Figure (7) shows another area of the same sheet where the pearlite content is obviously lower than those in figure (6), which indicates lower carbon content. In H.A.Z, abnormal grain growth is occasionally observed, as illustrated in figure (8), which indicates a tendency to secondary recrystallization. The H.A.Z. was characterized by unique granularity of ferrite as shown in figure (9); this fact added to the higher corrosion susceptibility of this zone, as illustrated in figure (10). The H.A.Z. shows two distinct areas, one with coarse grains (adjacent to the weld metal), while the other with finer grains (adjacent to the base metal), as shown in figure (11). The grain size in the H.A.Z. sudden changes indicate that the temperature gradient in welding was sharp, while the metal is of inherent fine-grained structure. The weld metal shows a typical “WIDMANSTAATEN” structure, as illustrated in figure (12), and (13) which indicate that the cooling rate on solidification was relatively high. Ferrite ejecting from austenite dendrites grew along certain crystallographic planes giving rise to the characteristic **widmanstaaten** structure.

**Figure (6): Ferrite-Pearlite Structure with Some Porosity, X500 “Normal Section of Heater Body”.**

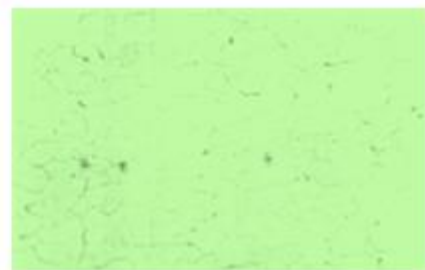
**Figure (7): Ferrite with Small Amount of Pearlite, X500 “Other Side of Heater”**

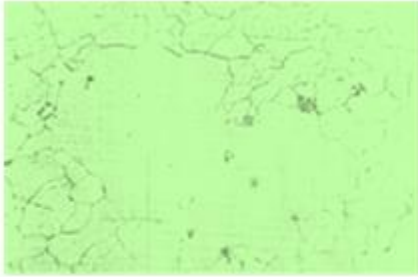
**Figure (8): Abnormal Grain Growth in H.A.Z. “Recrystallization” X500.**

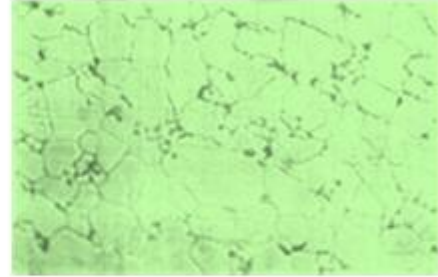
**Figure (9): Unequigranularity in H.A.Z.**

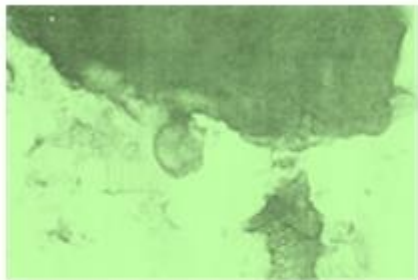
**Figure (10): Place of Pitting [Shows Removing of Some Grains Together], X500.**

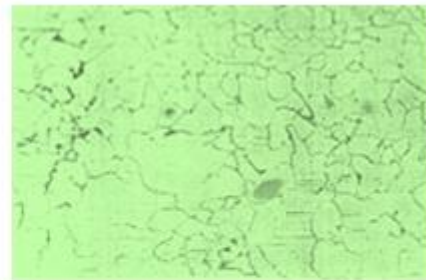
**Figure (11): Heat Affective Zone (H.A.Z.) X500.**

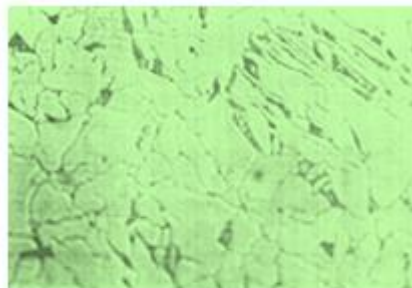
**Figure (12): Interface Between Weld Metal and H.A.Z, X500.**
